**INTERMOUNTAIN POWER SERVICE CORPORATION
DELTA, UTAH
OCTOBER 15, 1999
TLN 349G**

REPORT
INTERMOUNTAIN POWER SERVICE CORPORATION

Reference: Unit 2 – Coal Fired Boiler System

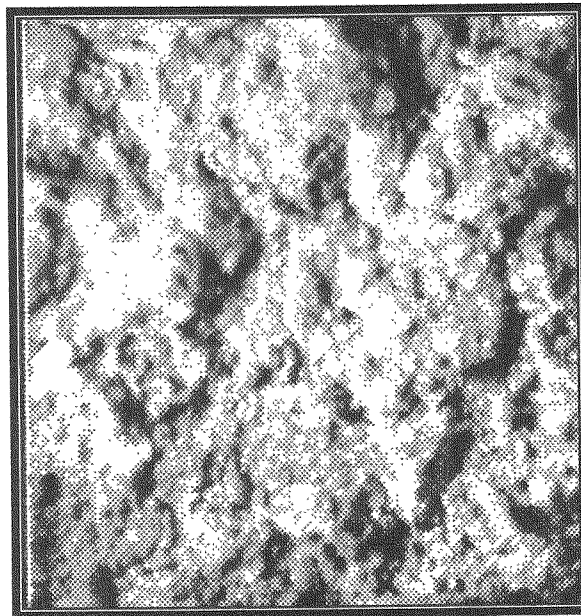
Photo A

The bag bottom area up to the third ring did exhibit ash dust agglomerations as shown by **Photo A**.

The dust was extracted in the bottom agglomerated area and yielded hygroscopic calcium sulphate as the binder of the nodule formation.

It is evident that this bag experienced moisture contamination limited the bottom area and contacted the hygroscopic ash sulphates generating the dense structure.

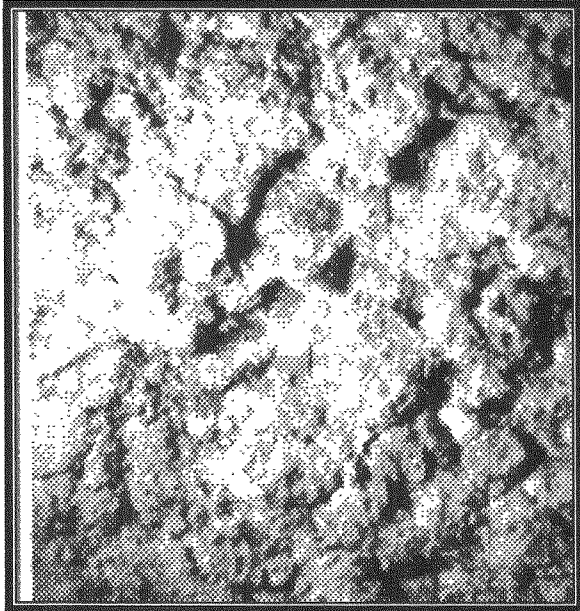
Photo B

In contrast, the middle zone (**Photo B**) and the top (**Photo C**) reveal a significantly different cake structure compared to the bottom area.

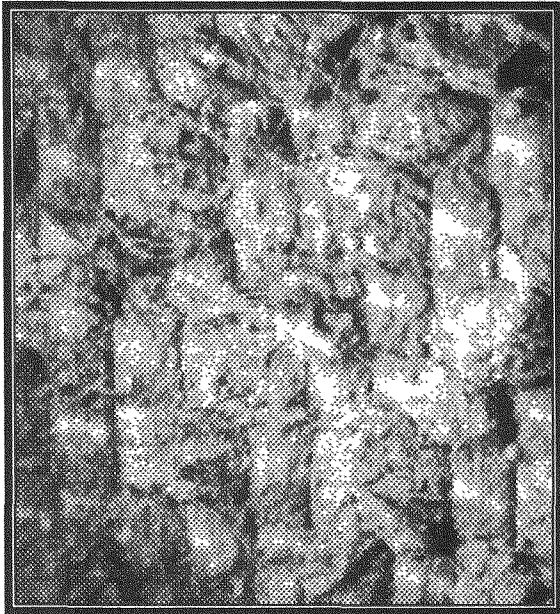
Reverse air flows allowed very good ash dust discharge with collection surface void recovery evident in the upper bag areas.

Photo D is a view of the good discharge characteristics off the collection surface.

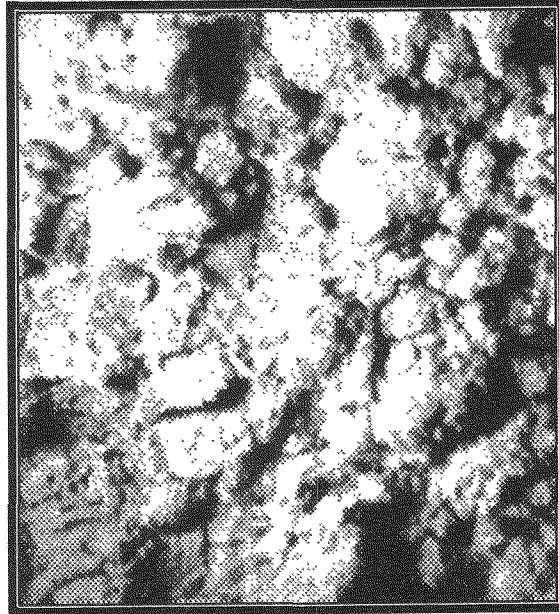
Photo E

The bottom area continued to retain the dense agglomerated dust with low voids within the structure as shown by **Photo E**.

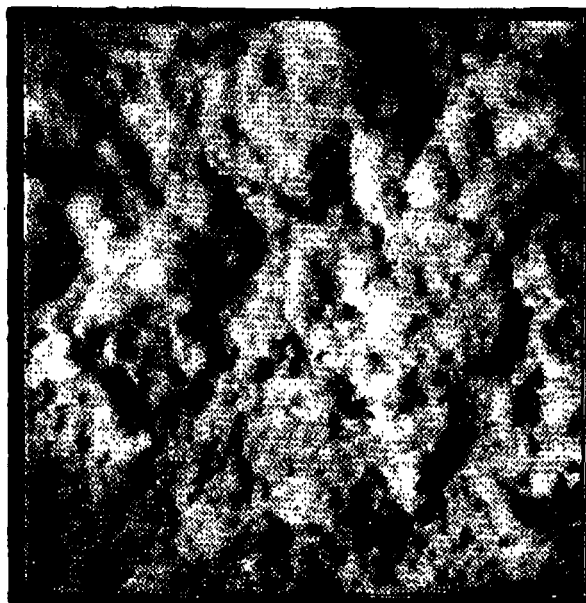
Photo A

The bag bottom area up to the third ring did exhibit ash dust agglomerations as shown by **Photo A**.

The dust was extracted in the bottom agglomerated area and yielded hygroscopic calcium sulphate as the binder of the nodula formation.

It is evident that this bag experienced moisture contamination limited the bottom area and contacted the hygroscopic ash sulphates generating the dense structure.
